Smoke and Dye Testing Summary

High Level Sewershed

Run Summary

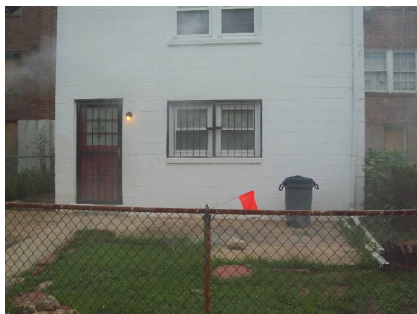
Picture \S1028-193-OB01-P01.jpg

Source Cleanout

Location Yard - back

Comments Smoke from cleanout in back yard. 2519 Mosher St.

Comments Back of house, 2519 Mosher St.
